Report on Final Site Classification & Construction Testing

The Vintage Development – The Cedars
Pokolbin, NSW

Project Number: 304001563

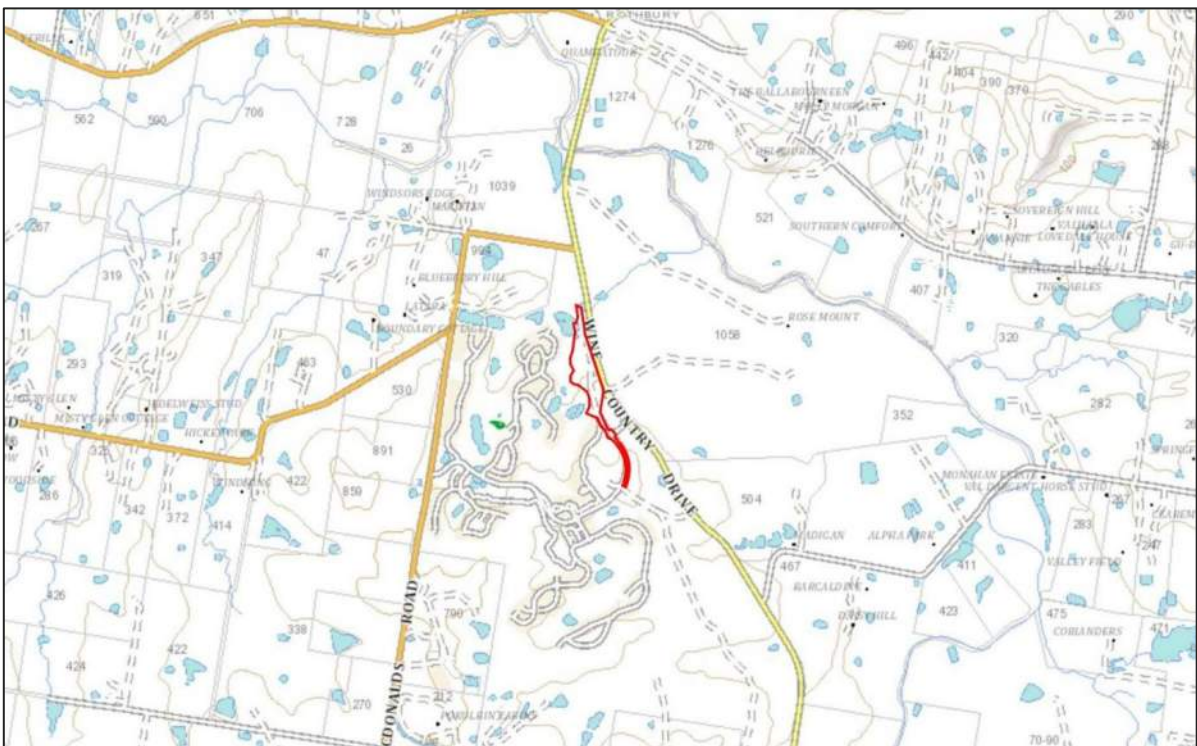
Figure 1: Site Locality

The approximate extent of the development is outlined below in Figure 1:

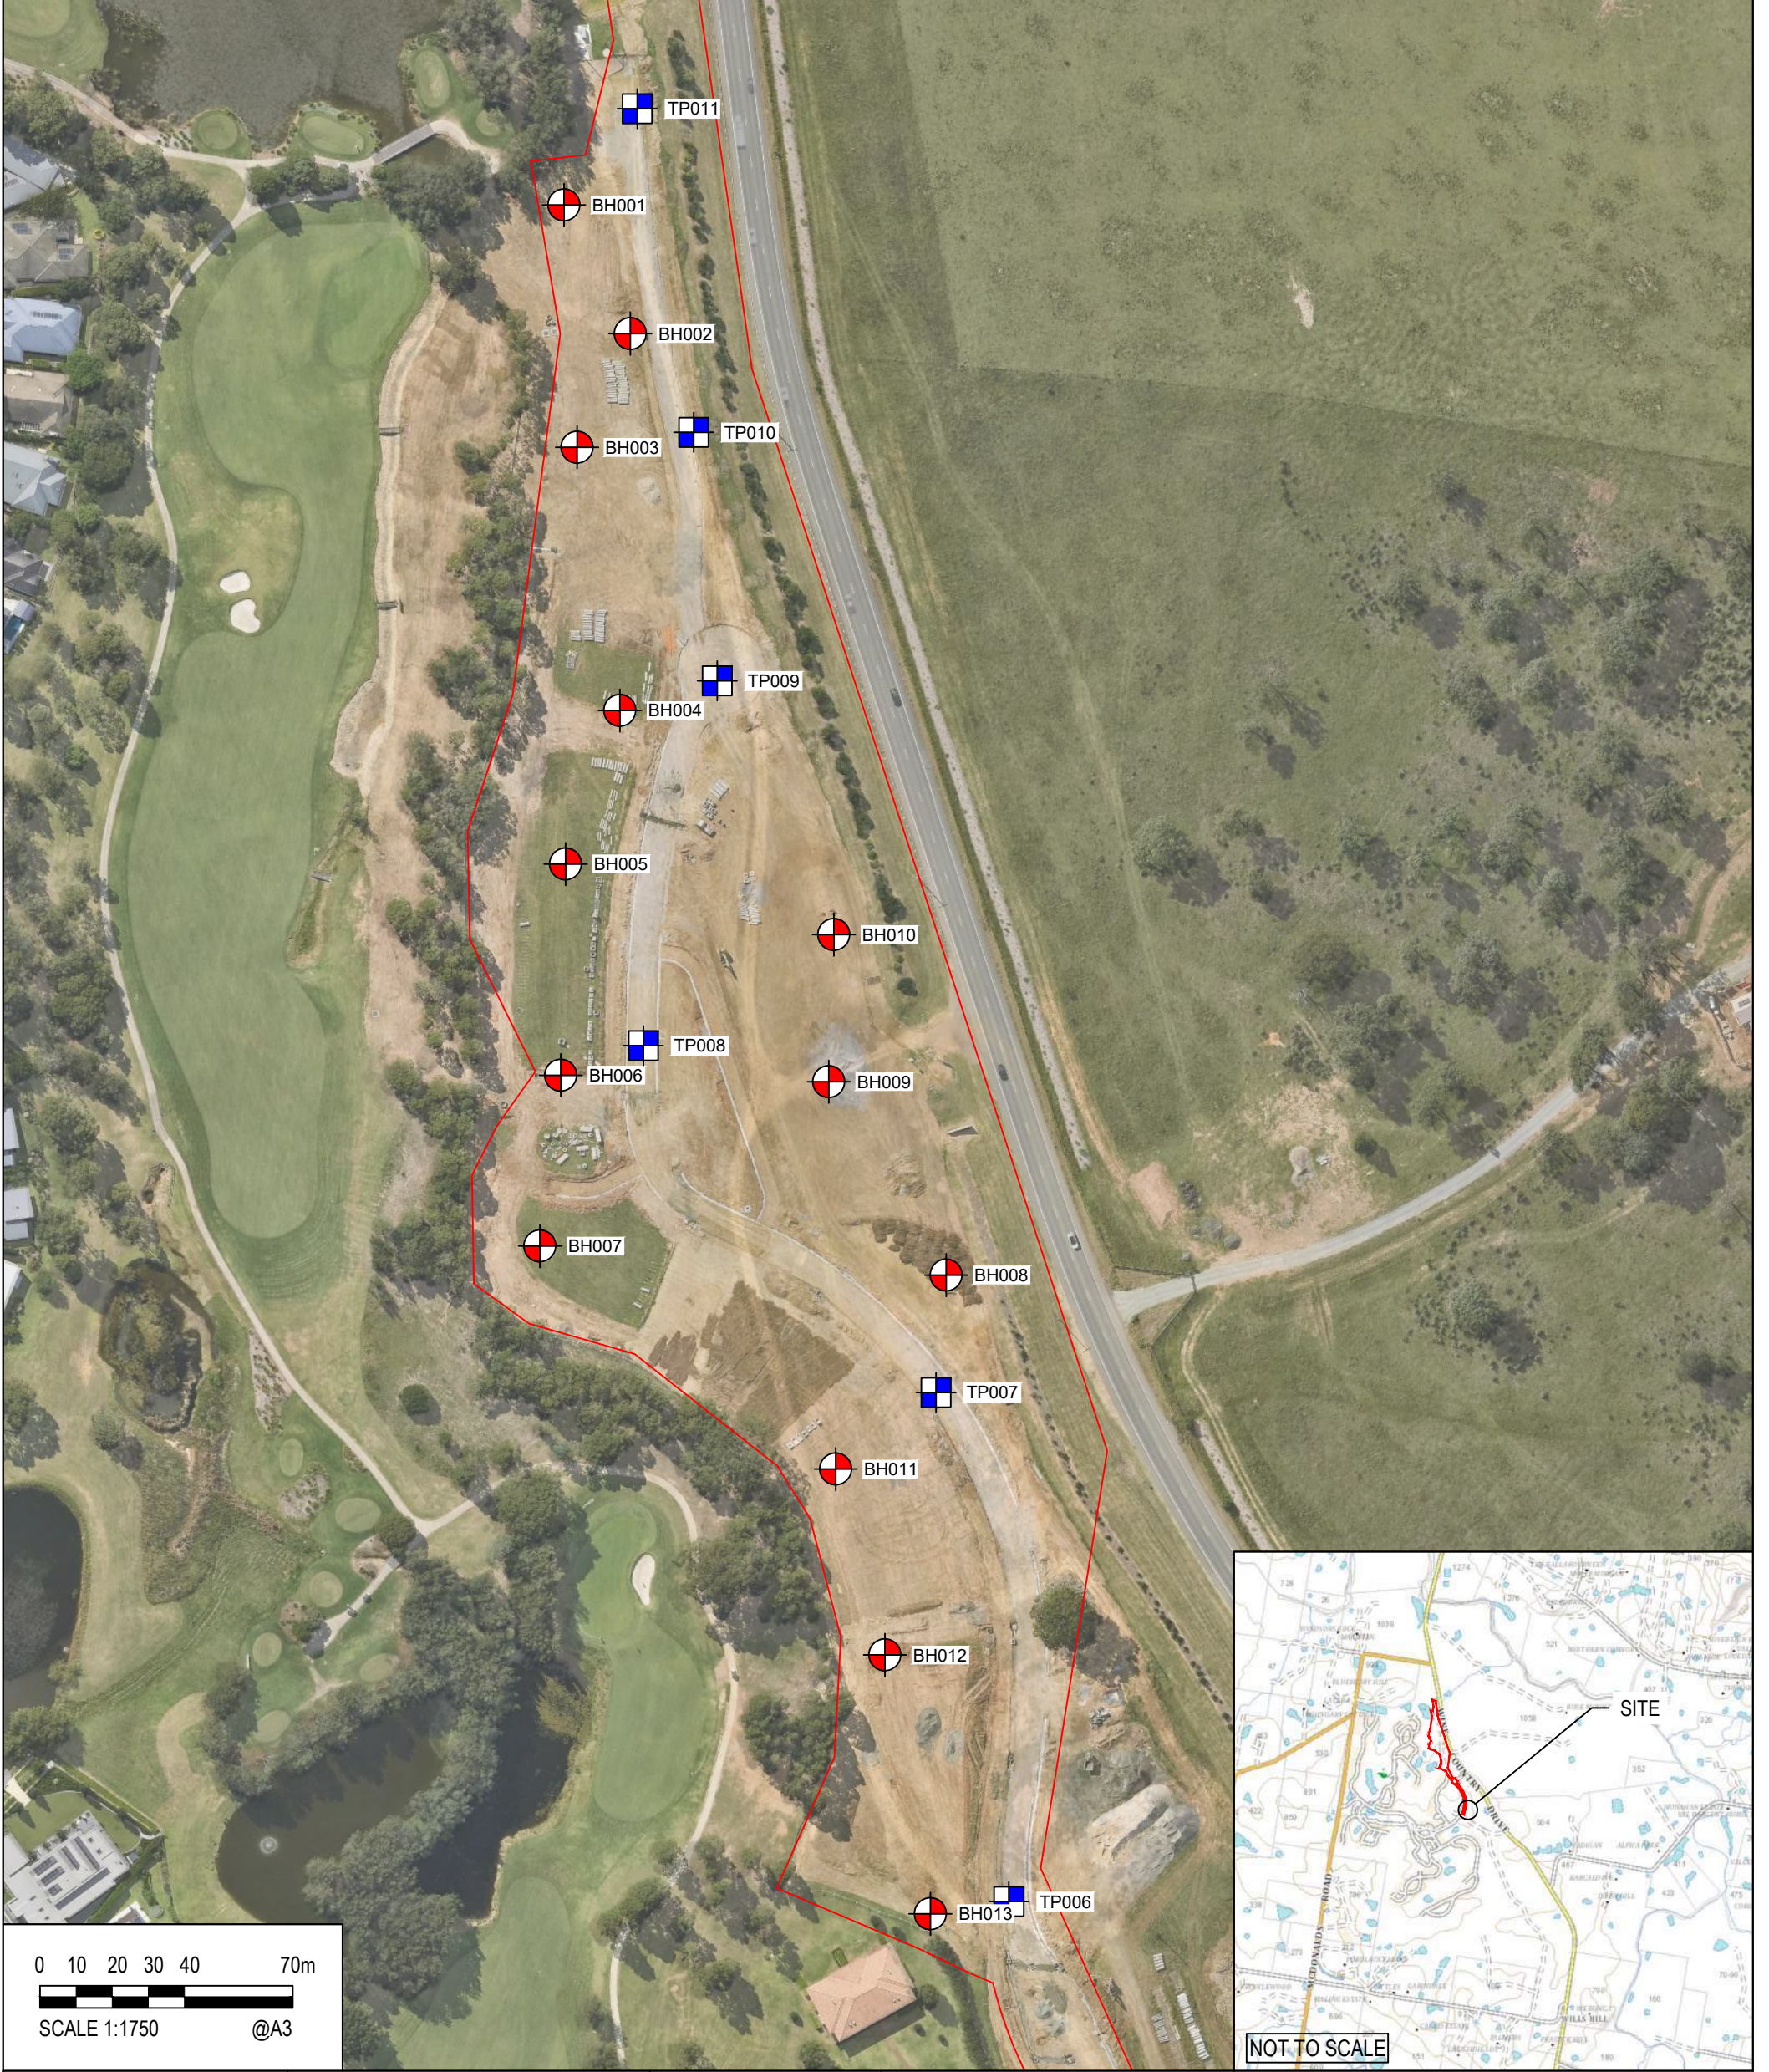
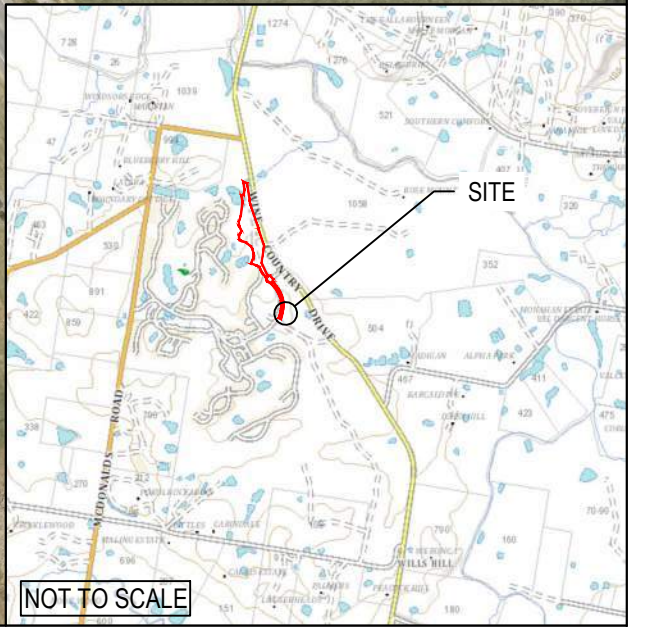
Status	FOR INFORMATION ONLY NOT TO BE USED FOR CONSTRUCTION PURPOSES		
Project Number	304001563	Scale	1:1750
Figure Number	Site Plan Figure 1	Size	A3
Revision	A

TPXXX Approximate test bore locations and numbers from previous investigation (ref. 304100678, dated. 6/07/2022).

All fieldwork including logging of subsurface profiles and collection of samples was conducted by a geotechnical consultant from Stantec. Test locations are shown overlaid on aerial imagery and client supplied plans in Figures 1 and 2, attached as Appendix A.

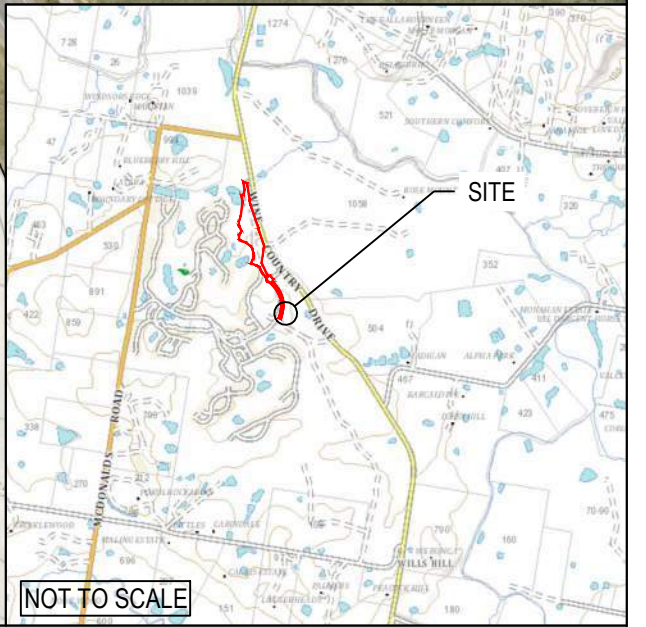
Status	FOR INFORMATION ONLY NOT TO BE USED FOR CONSTRUCTION PURPOSES			
Project Number	304001563	Scale	1:1750	
Figure Number	Site Plan Figure 2		Size	A3
Revision			Revision	A

TPXX Approximate test bore locations and numbers from previous investigation (ref. 304100678, dated. 6/07/2022).

Approximate extent of additional earthworks (Deleted sewer line backfill)

The complete design regrade is detailed within the supplied bulk earthworks plans [1] and is shown overlaid in Figure 2, attached in Appendix A. The plans should be referenced for detailed overview of proposed earthworks.

The approximate extent of additional earthworks can be seen depicted in Figure 2, and Robsons WAE survey [2] depicting stripped surface vs. finished levels for allotments, attached in Appendix A.

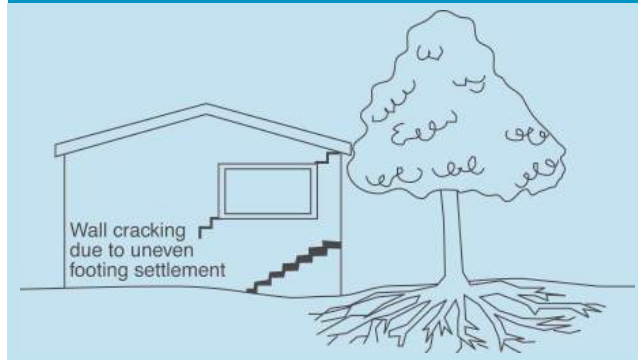
Trees can cause shrinkage and damage

As the weather pattern changes and the soil begins to dry out, the external footings will be first affected, beginning with the locations where the sun's effect is strongest. This has the effect of lowering the external footings. The doming is accentuated and cracking reduces or disappears where it occurred because of dishing, but other cracks open up. The roof lines may become convex.
